**GEOLOGIC/GEOTECHNICAL HAZARDS STUDY  
HARBOR TERRACE CAMPGROUND  
PORT SAN LUIS  
COUNTY OF SAN LUIS OBISPO, CALIFORNIA**

August 22, 2014

PROJECT: HARBOR TERRACE CAMPGROUND  
PORT SAN LUIS  
COUNTY OF SAN LUIS OBISPO, CALIFORNIA

SUBJECT: GEOLOGIC/GEOTECHNICAL HAZARDS STUDY

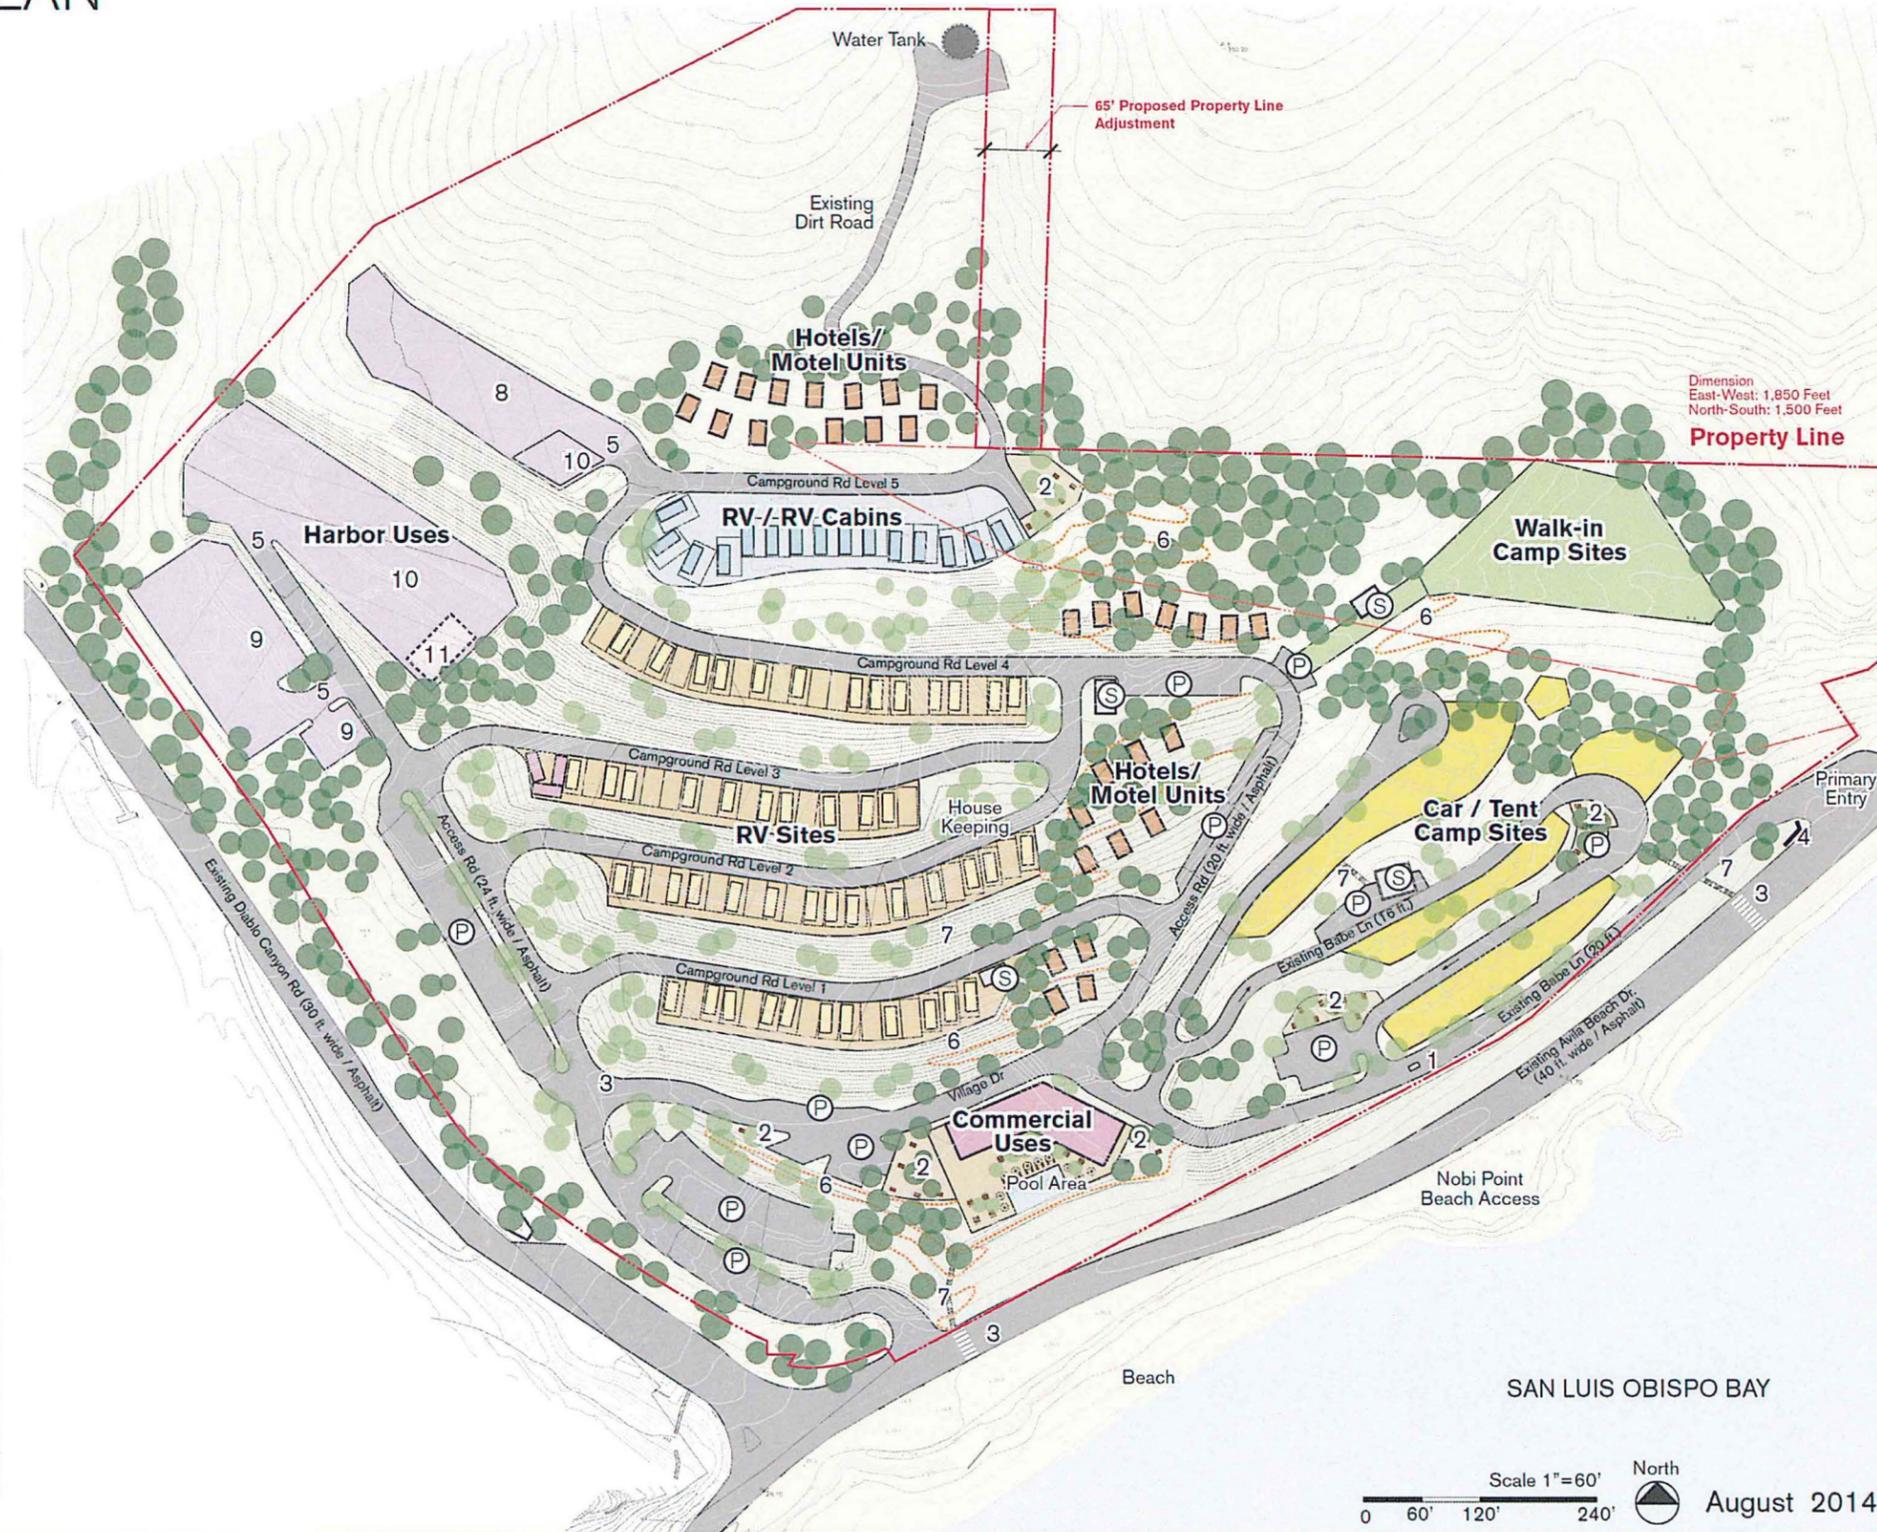
# SITE LAYOUT PLAN

Dimension  
East-West: 1,950 Feet  
North-South: 1,500 Feet  
**Property Line**

Scale 1"=60'  
0 60' 120' 240'  
North  
August 2014
